# Refitting New Rear Hubs to the TR6

Ron Weber

Central PA Triumph Club

3/05/2011

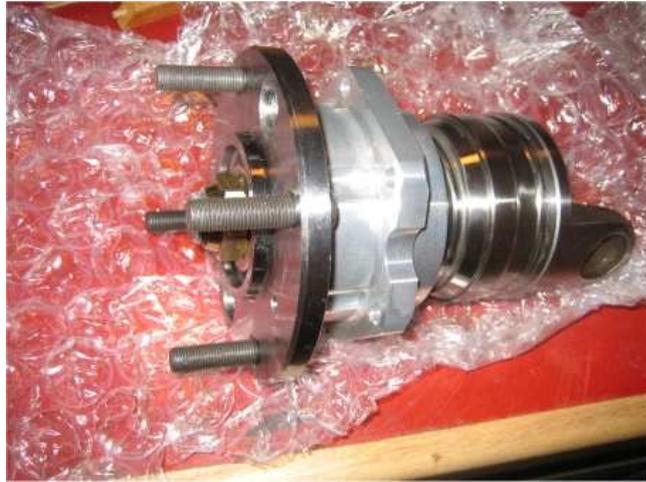
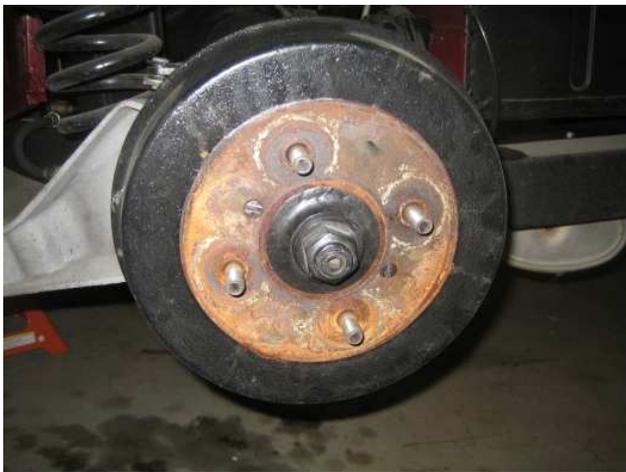
Ok, now that the decision was made to tackle the hubs, I had another decision to make: rebuild the hubs myself, order a rebuilt set from TRF, or get a set of Good Parts hubs. Although it would be the least expensive route at roughly \$100 per hub, I really didn't want to mess with making the tools needed to rebuild the existing hubs and run the risk of completely bugging them up. That left two options: buy TRF rebuilt hubs at \$300 a piece or buy Good Parts hubs at \$349 each. Both require PA sales tax and with TRF's shipping costs, it was just about a wash from a cost standpoint. Given that it is a 45 min drive to Good's garage, I opted for the Good Parts hubs after reading positive comments on BCF. These hubs are much improved over stock hubs and utilize modern materials and feature double row angular contact sealed ball bearings that, if required, are easily replaced.

After picking up the hubs from Richard Good's garage, I brought them home and unwrapped them. These hubs are works of art! They're beautifully machined and finished to the point it is a shame to hide them in a trailing arm housing. Well, ya gotta do what ya gotta do so here's how to replace them...

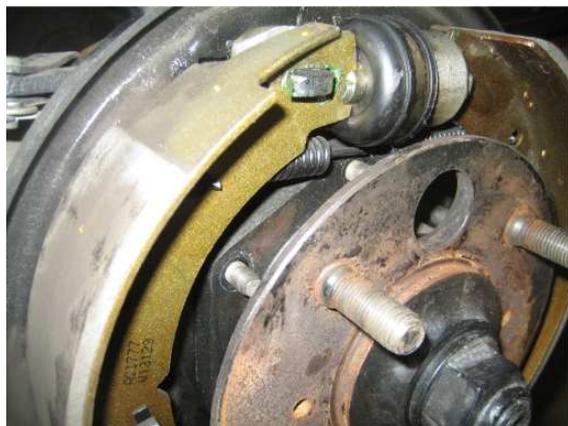
When the drum is off, the hub is visible. It's pretty easy to remove the hub at this point. Line up the holes in the hub to expose the nuts that retain the hub to the trailing arm and use a socket on an extension to remove each pair of nuts. Throw the nuts out since they shouldn't be reused. Before pulling the hub out, use a pair of side cutters to clip the wire wrap that secures the rubber inner shaft boot to the outer shaft boot.

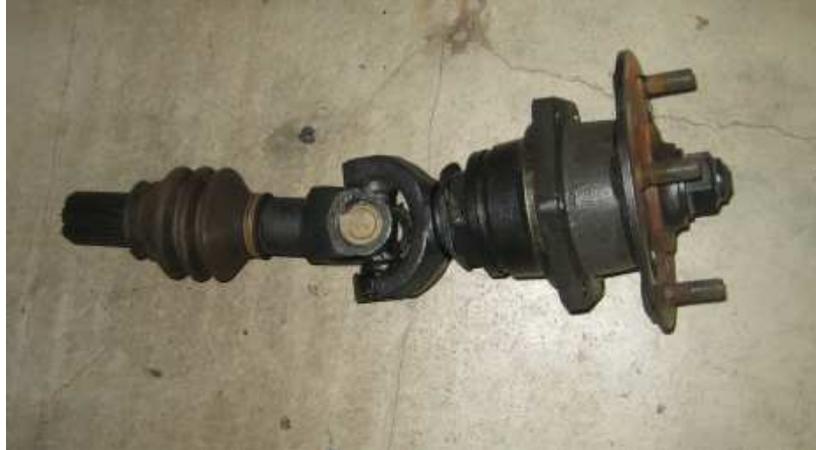
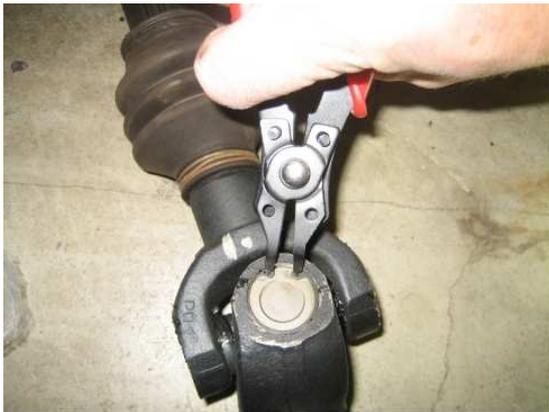
Next, pull the entire hub assembly out through the trailing arm. At this point you'll have the hub assembly with  $\frac{1}{2}$  the  $\frac{1}{2}$  shaft (I guess that makes it a quarter shaft).

Using a pair of ring clip pliers, remove the two ring clips where the hub connects to the universal joint. Depending on when you last touched the universal joint, it may be easy to tap out the bearing cups or you may end up needing to press them out with a hydraulic press. I used a socket that was just slightly smaller than the cup diameter to tap out the universal joints. If they've been in there long enough to need a press, this may be a good opportunity to replace them with new ones.

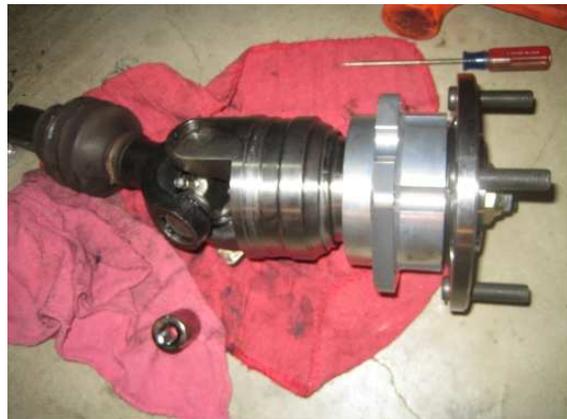
The next step is to install the stub  $\frac{1}{2}$  shaft and universal joint on the new hub. Position the existing universal cross shaft in the new hub yoke and use a socket and small hammer to tap each of the two cups back onto the cross shaft ends. Take care not to displace any of the needle bearing rollers in the cups while you're reassembling and, most importantly, do this on a clean surface. Any grit, dust or debris will cause the joint to pre-maturely self-destruct.

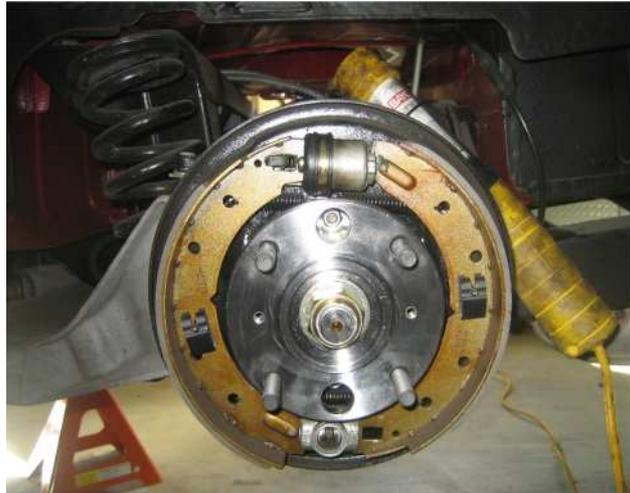
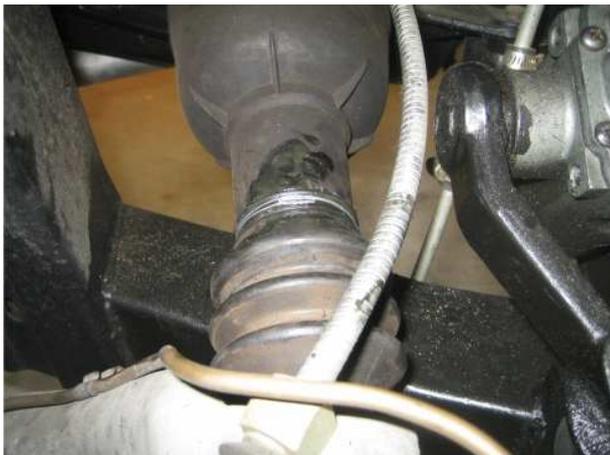
The hub is now ready for re-installation. Grease the spline and universal joint now while everything is accessible. It's probably not a bad idea to grease the inner shaft universal joints too at this time. Slide the hub back into the trailing arm making sure to align the inner and outer splined shaft halves. There is a large flat on the spline to properly orient everything so make sure to take note of where it is before you start and save yourself some frustration. Use new 5/16" Nylock nuts (that Richard thoughtfully includes) to secure the hub to the trailing arm using a torque wrench set to between 12-16 ft-lbs.

Make sure the two boot halves overlap and install a new wrap-wire on the outer rubber boot end to secure the two halves. Reinstall the brake drum, mount the tire, and readjust the brakes. Repeat the process on the other side and you're now ready for the road again!
